Weavers Reach, Wellington

Footbridge Inspection Report

Inspection date: 20th February 2024

Prepared for:
Wellington Town Council,
28 Fore Street,
Wellington,
Somerset
TA21 8AQ

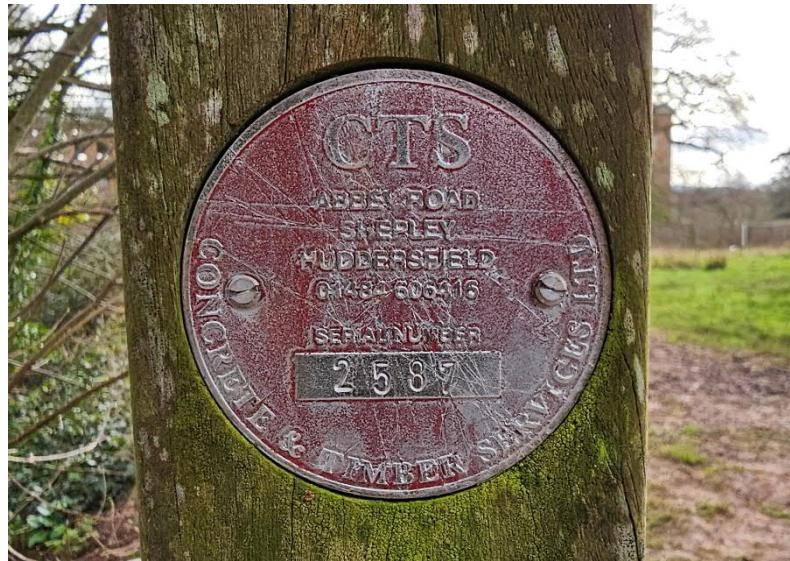
Figure 3: Bridge manufacturer's plaque.

The bridge has a manufacturer/installer plaque fixed to the parapet at the bridge's western end, southern side. See Figure 3.

The bridge's manufacturer should be contacted, and design and maintenance information still held by them obtained. See Figure 3

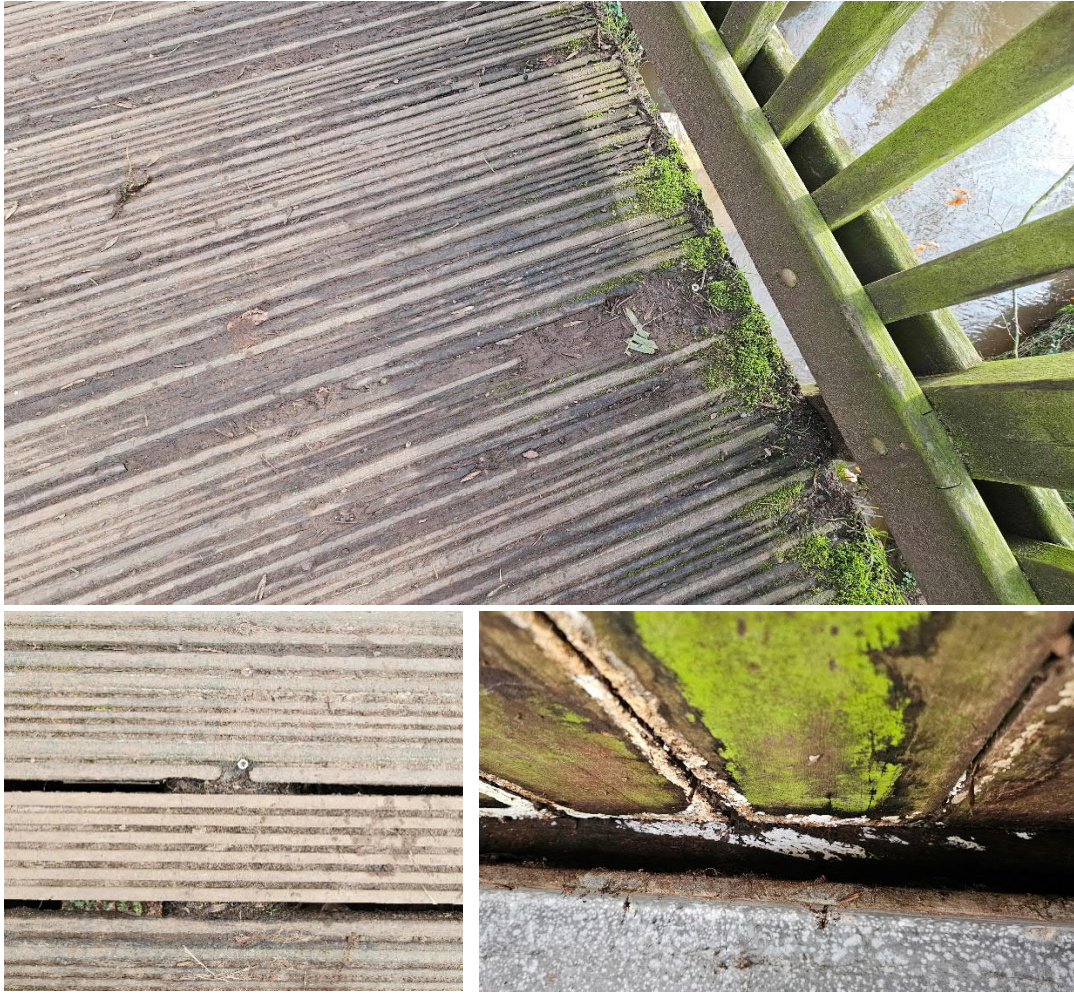
Figure 7: Deck surfacing showing decayed areas of boards.

A number of these boards (around 20no.) are in a state of decay that will necessitate their replacement in the near future. See Figure 7.

- Some of the timber planks forming the deck have decayed to reduce their effective thickness and therefore strength. Approximately 20 no.

These shall be replaced at the soonest opportunity.

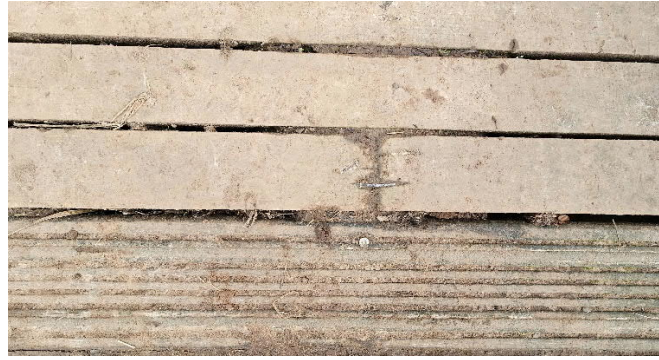
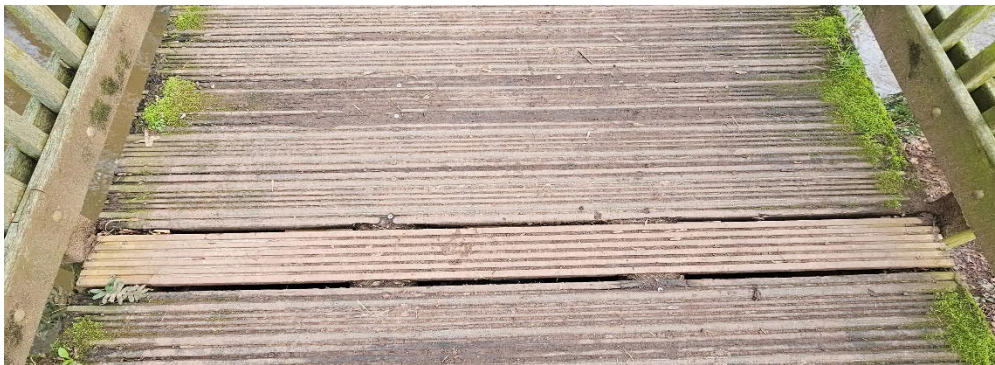
Figure 8: Deck surfacing showing unsuitable replacement boards.

A number of these boards (around 10no.) have been replaced with either planed wood boards or decking boards without anti-slip strips. The replacement boards are unsuitable as they do not match the adjacent boards sufficiently well and/or present a slip hazard. See Figure 8.

Occasional, the fixings for these boards are exposed, incorrectly used, or unsuitable. These boards and their fixings should be replaced. See Figure 8.

- Some of the original timber planks have already been replaced with unsuitable timbers, these include decking board that do not have anti-slip strips (approximately 10 no.) and others that appear untreated planed planks fixed with nails that protrude from the deck surface (approximately 5 no.) .

These shall be replaced at the soonest opportunity.

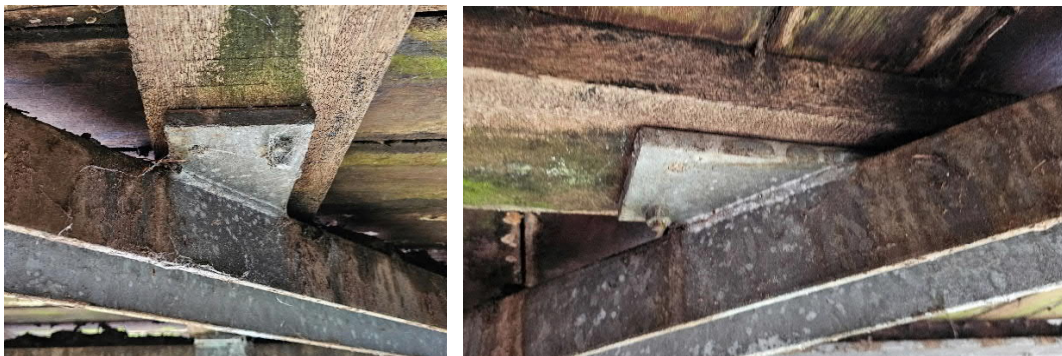
Figure 9: Deck board bearer locating fixings missing (example of).

The decking surfacing boards are supported on timber bearers. These are located one atop each of the main girders and one at each side of the middle-third of the decking span (spans side to side). The central timber bearers are supported off the lateral and cross bracing members using welded steel plate/RSA. A number of the locating hole through the supports are not utilised. See Figure 9. This is of no significant detriment to the deck support but at the next routine maintenance visit these locator fixings should be installed.

- Numerous location fixings are missing between the steel structure and the timber decking elements.

These should be installed as part of the bridge's on going maintenance.

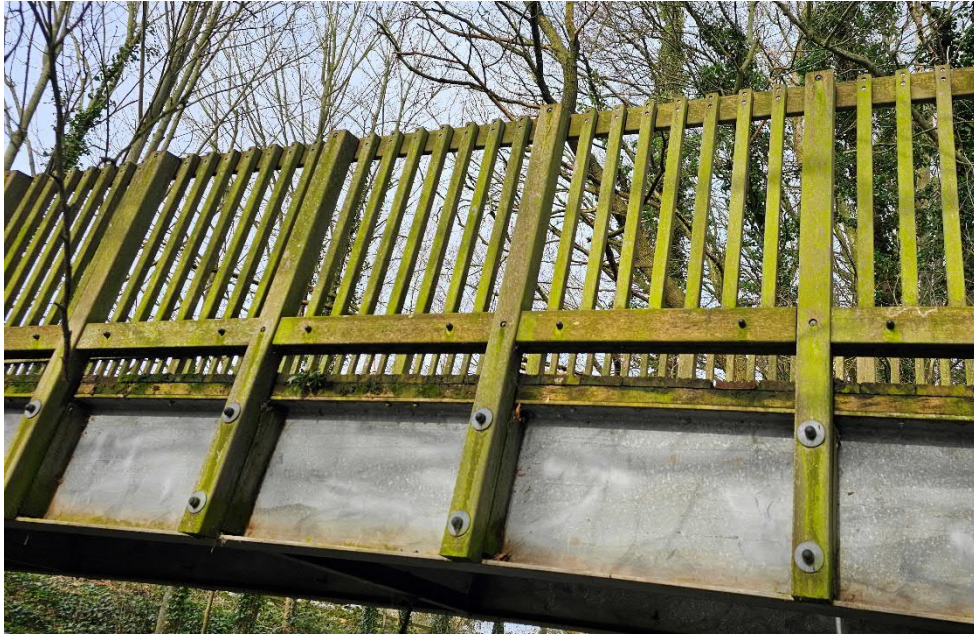
Figure 10: Parapet arrangement.

The parapets to the bridge are 1.12 m high and are provided by a timber post and rail system. See Figure 10.

The parapets are in a good condition.

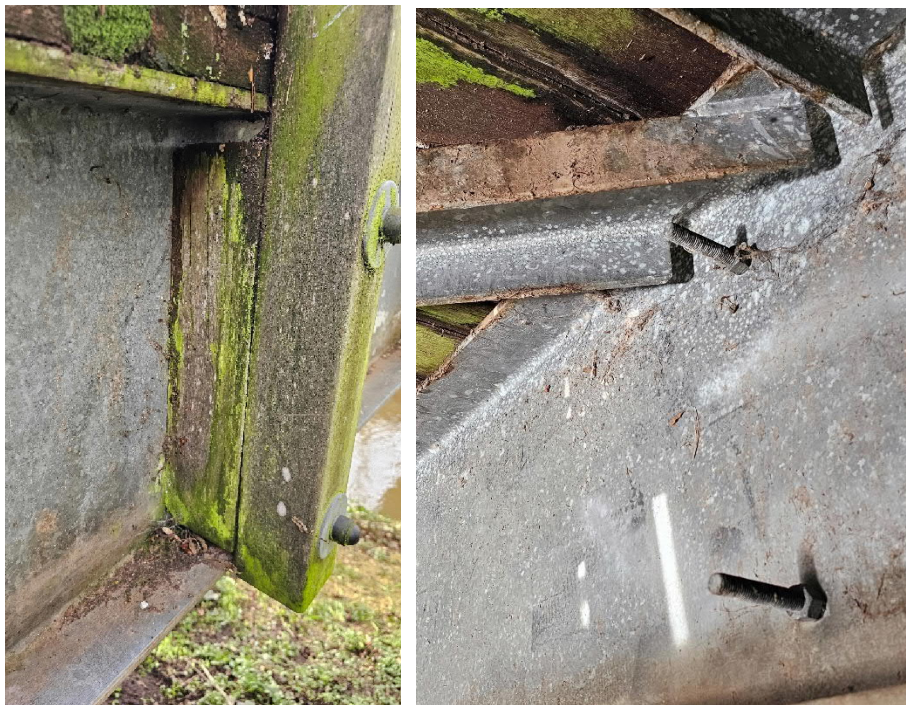
Figure 11: Parapet fixings showing nut on underside of bridge and spacer on outer face of girder.

The main posts are connected to the main girders with a bolted connection through the girder web and using a timer spacer to offset the post around the girder flange. See Figure 11.

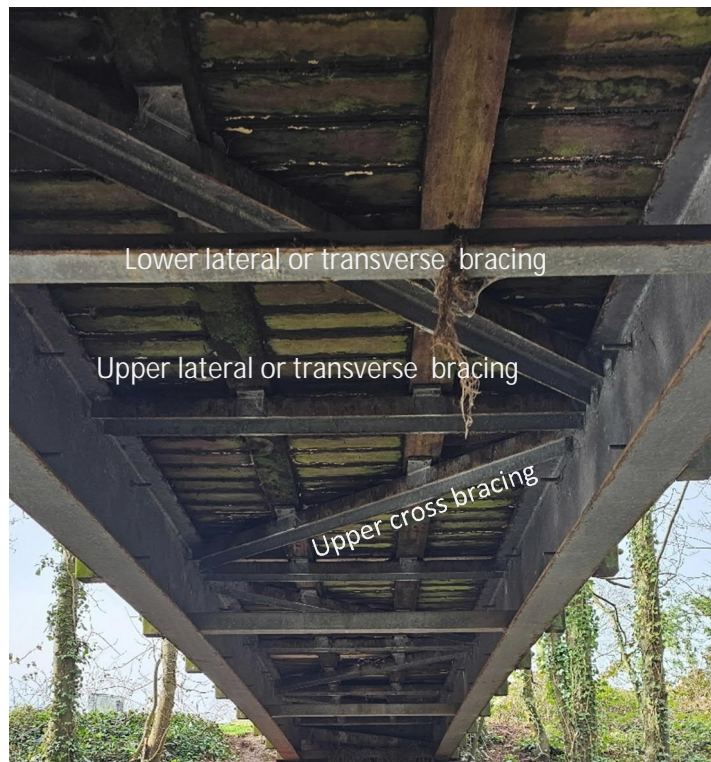
Figure 12: Bridge underside.

The upper lateral bracing of the bridge comprises of 150 x 75 x18 PFC sections welded to the upper flange of the main girders at 1.94 m centres.

The upper lateral bracing is in a good condition.

The upper cross/plan bracing of the bridge comprises of 150 x 75 x18 PFC sections welded to the upper flange of the main girders and spanning diagonally between the connection points for the upper lateral bracing.

The upper lateral bracing of the bridge comprises of 95 x 95 x 7 RSA sections welded to the lower flange of the main girders at 3.1 m centres.

The lower lateral bracing is in a good condition.

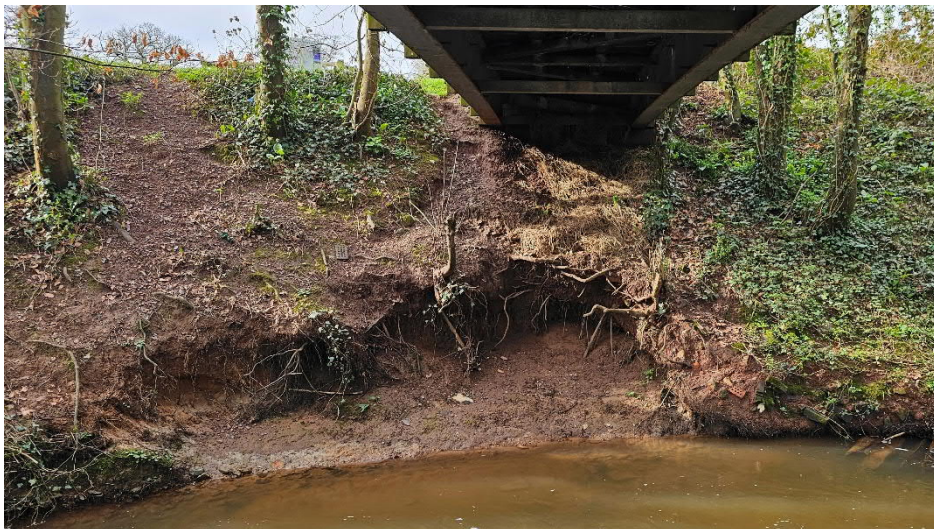
Figure 13: Western abutment.

The abutment's construction is unknown as it is predominately buried. It is likely a mass concrete structure. See Figure 13.

The abutment is likely to be in a good condition.

The bank between the abutment and the river has eroded. In time this may compromise the abutment. See Figure 13.

- Bank erosion below the west abutment.

This shall be monitored and remedial action taken should it become necessary.

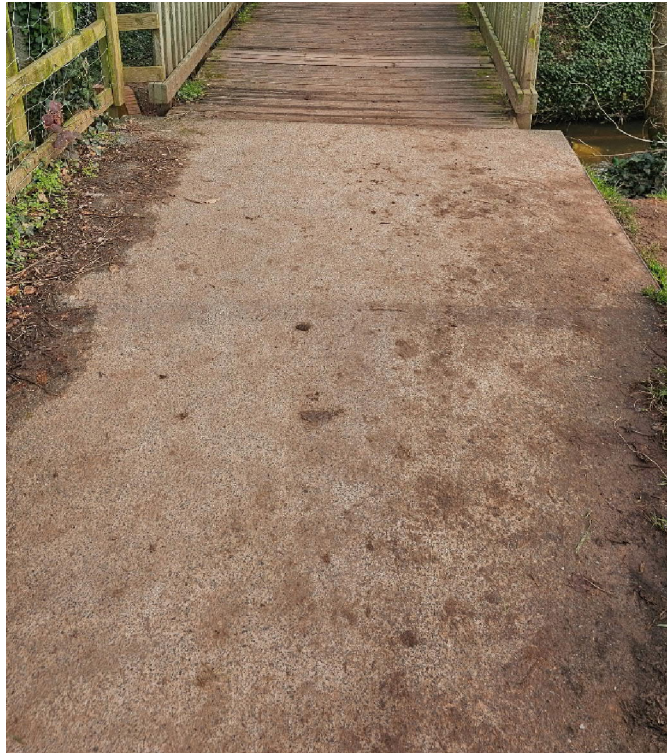
Figure 14: Western approach.

The bridge approach is shown in Figure 14. The approach is a concrete surfaced footway with a post and rail fence at to the northern side.

The post and rail fence is in a fair condition whilst the surfacing is in a good condition.

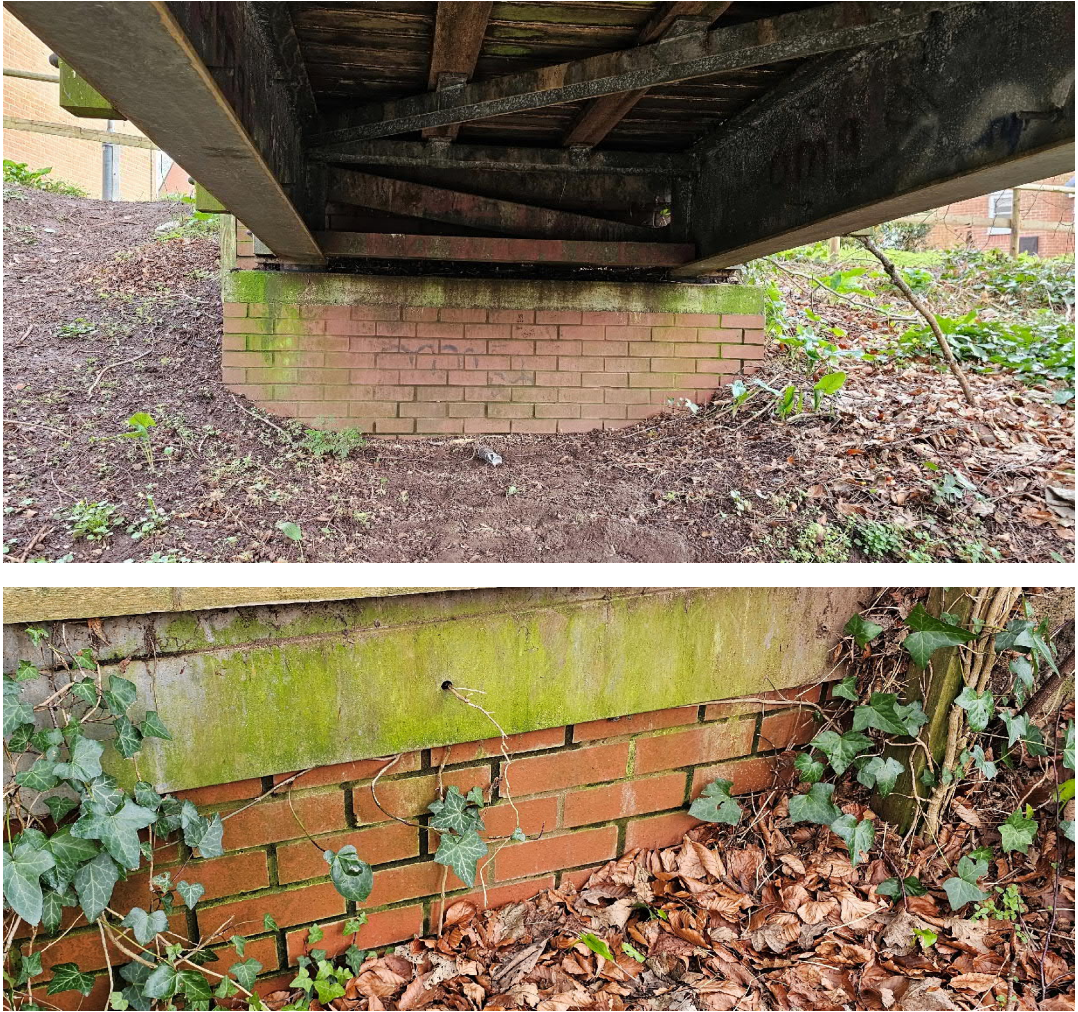
Figure 15: East abutment.

There are minor brick laying defects whereby the face of the abutment has a slight (10 mm) step in it. See Figure 15.

The abutment is in a good condition.

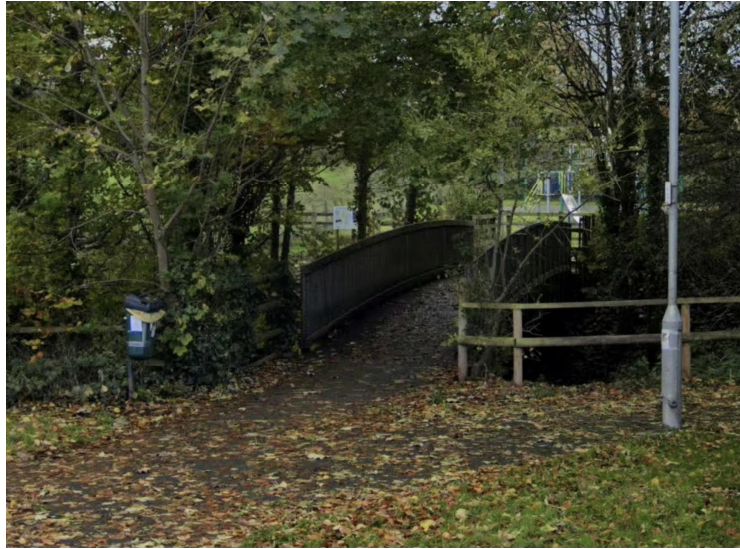
Figure 16: Western approach (google image).

The bridge approach is shown in Figure 14. The approach is an asphalt surfaced footway with a post and rail fence at each side.

The post and rail fence is in a fair condition whilst the surfacing is in a good condition.

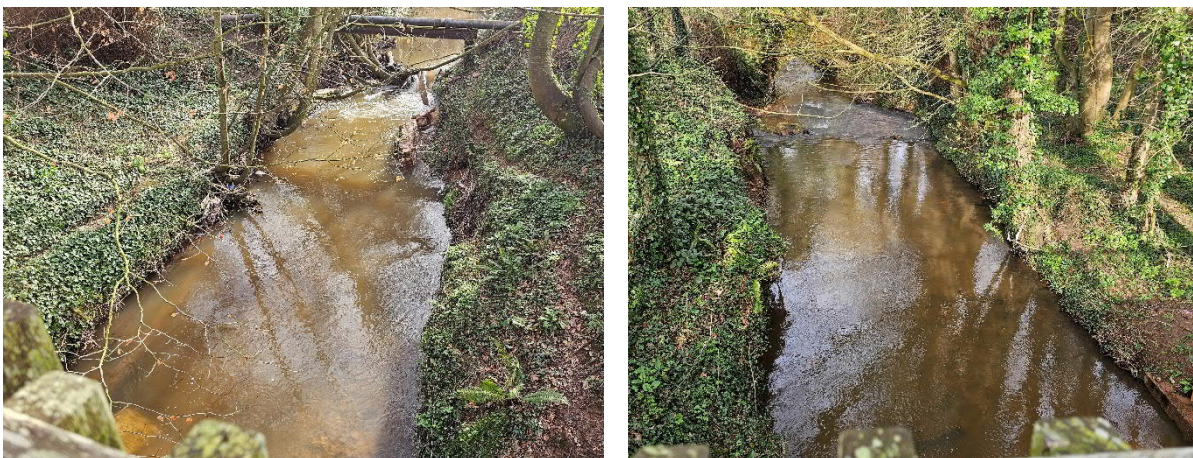
Figure 17: Back Stream crossed
(left image is looking upstream (south) and right image is looking downstream (north)).

The river and riverbanks have some engineering to them. These features are in various states of repair.

- Around 30 m up stream is a pipe bridge, below which is a weir or artificial dam of debris.
- Between the pipe bridge and the footbridge there is a piece of failed canalisation wall on the west bank
- About 5 m downstream on the east bank is a drainage outfall head wall.
- Approximately 30 m downstream the river flow appears to change from sub- to super-laminar.

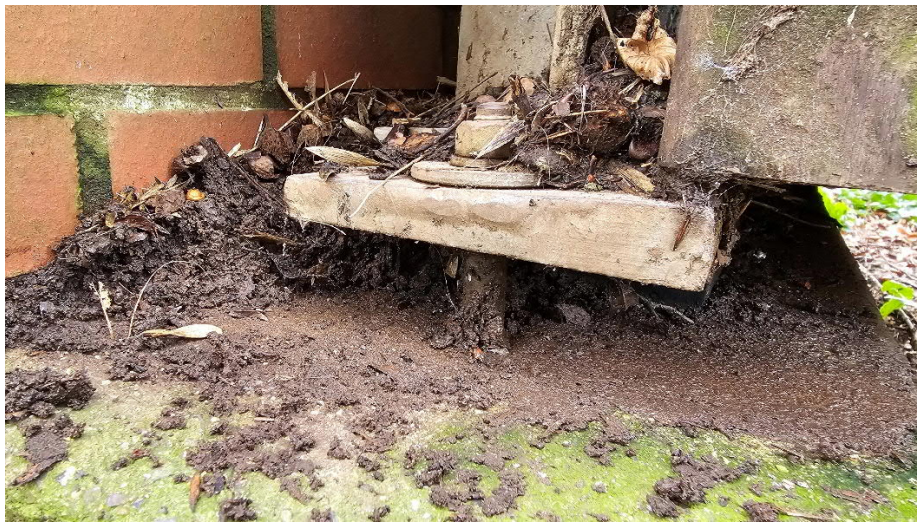
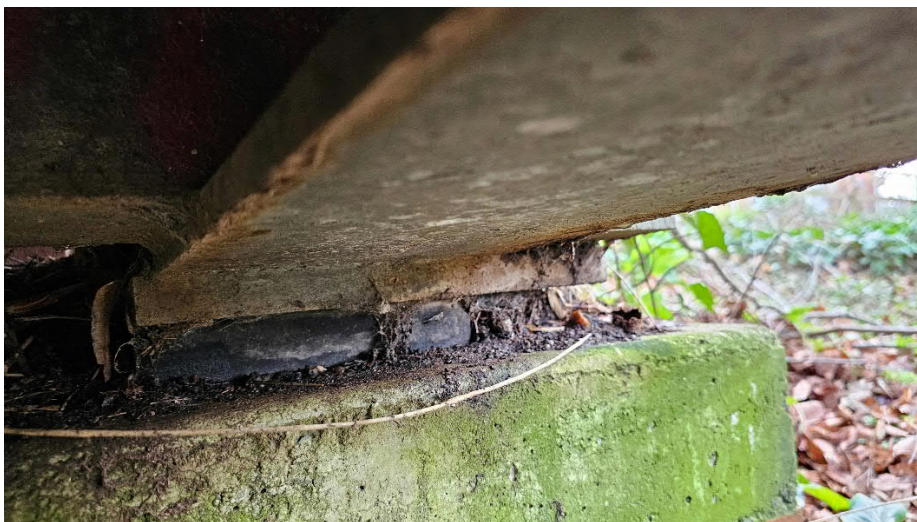
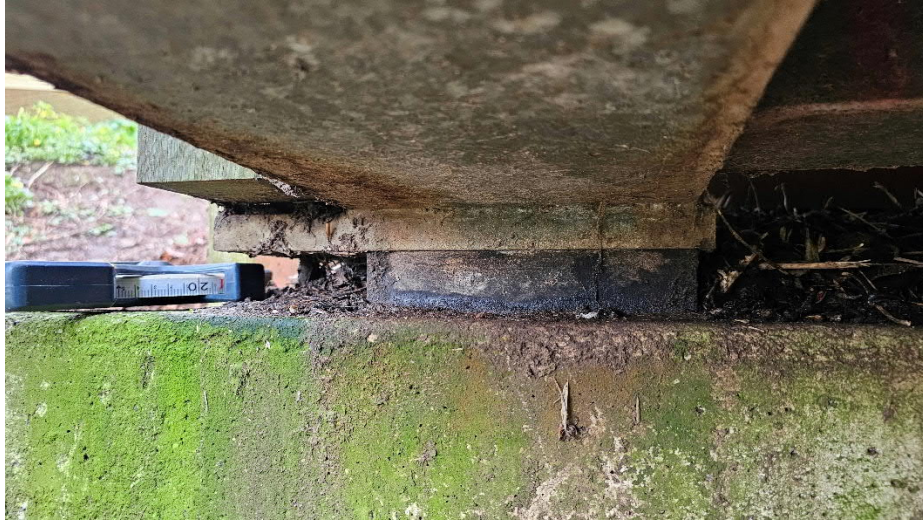
Figure 18: bearing pad below flange of main girder (example).

The bearings comprised an elastomer rubber pad located below the bearing of each main girder at each end. The pad does not extend under the whole bearing plate only below the flange of the main girder. See Figure 18.

- Bearing plate extends beyond the bearing elastomer pad.

This shall be monitored and remedial action taken should it become necessary.
