Weavers Reach, Wellington

Footbridge Inspection Report

Inspection date: 20th February 2024

Prepared for:
Wellington Town Council,
28 Fore Street,
Wellington,
Somerset
TA21 8AQ

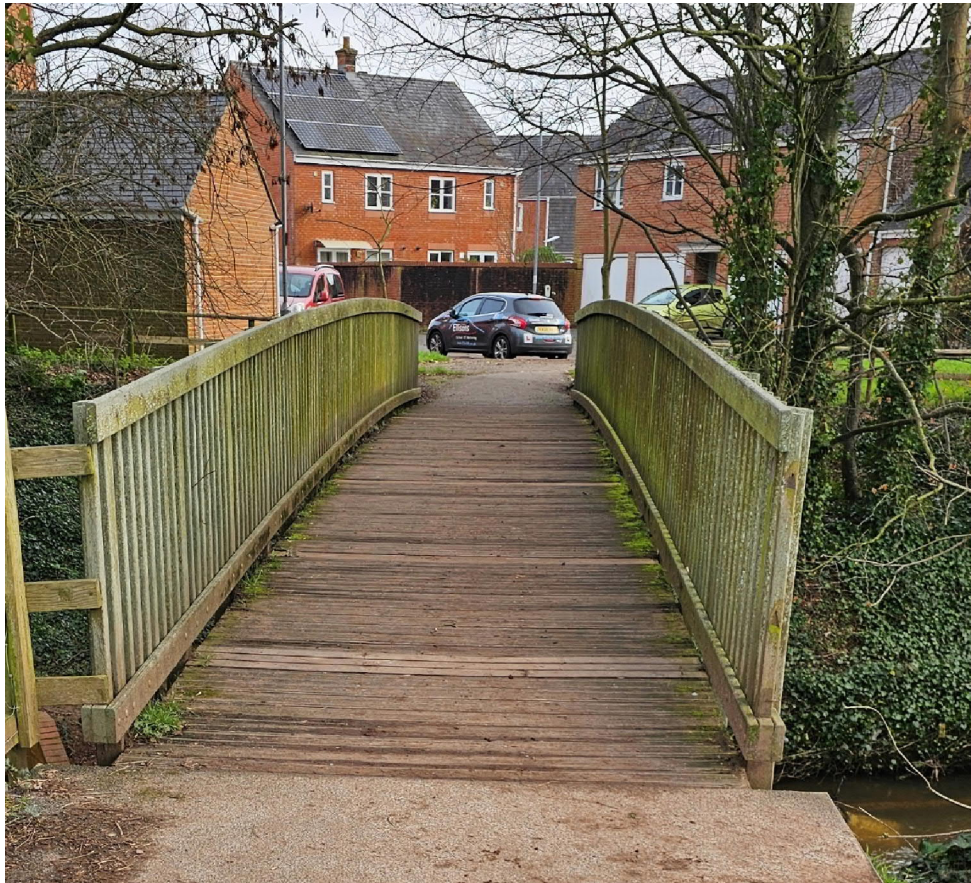
Figure 6: *West looking east along bridge.*

The surfacing is, generally, timber decking boards with anti-slip strips. See Figure 6.
